Re: Property-Specific Remedial Action Report
Newhall Street Neighborhood
976 Winchester Avenue, Block Q
Hamden, Connecticut 06517

**PROPERTY-SPECIFIC REMEDIAL ACTION REPORT
976 WINCHESTER AVENUE**

**NON-PUBLIC PROPERTIES
NEWHALL STREET NEIGHBORHOOD
HAMDEN, CONNECTICUT**

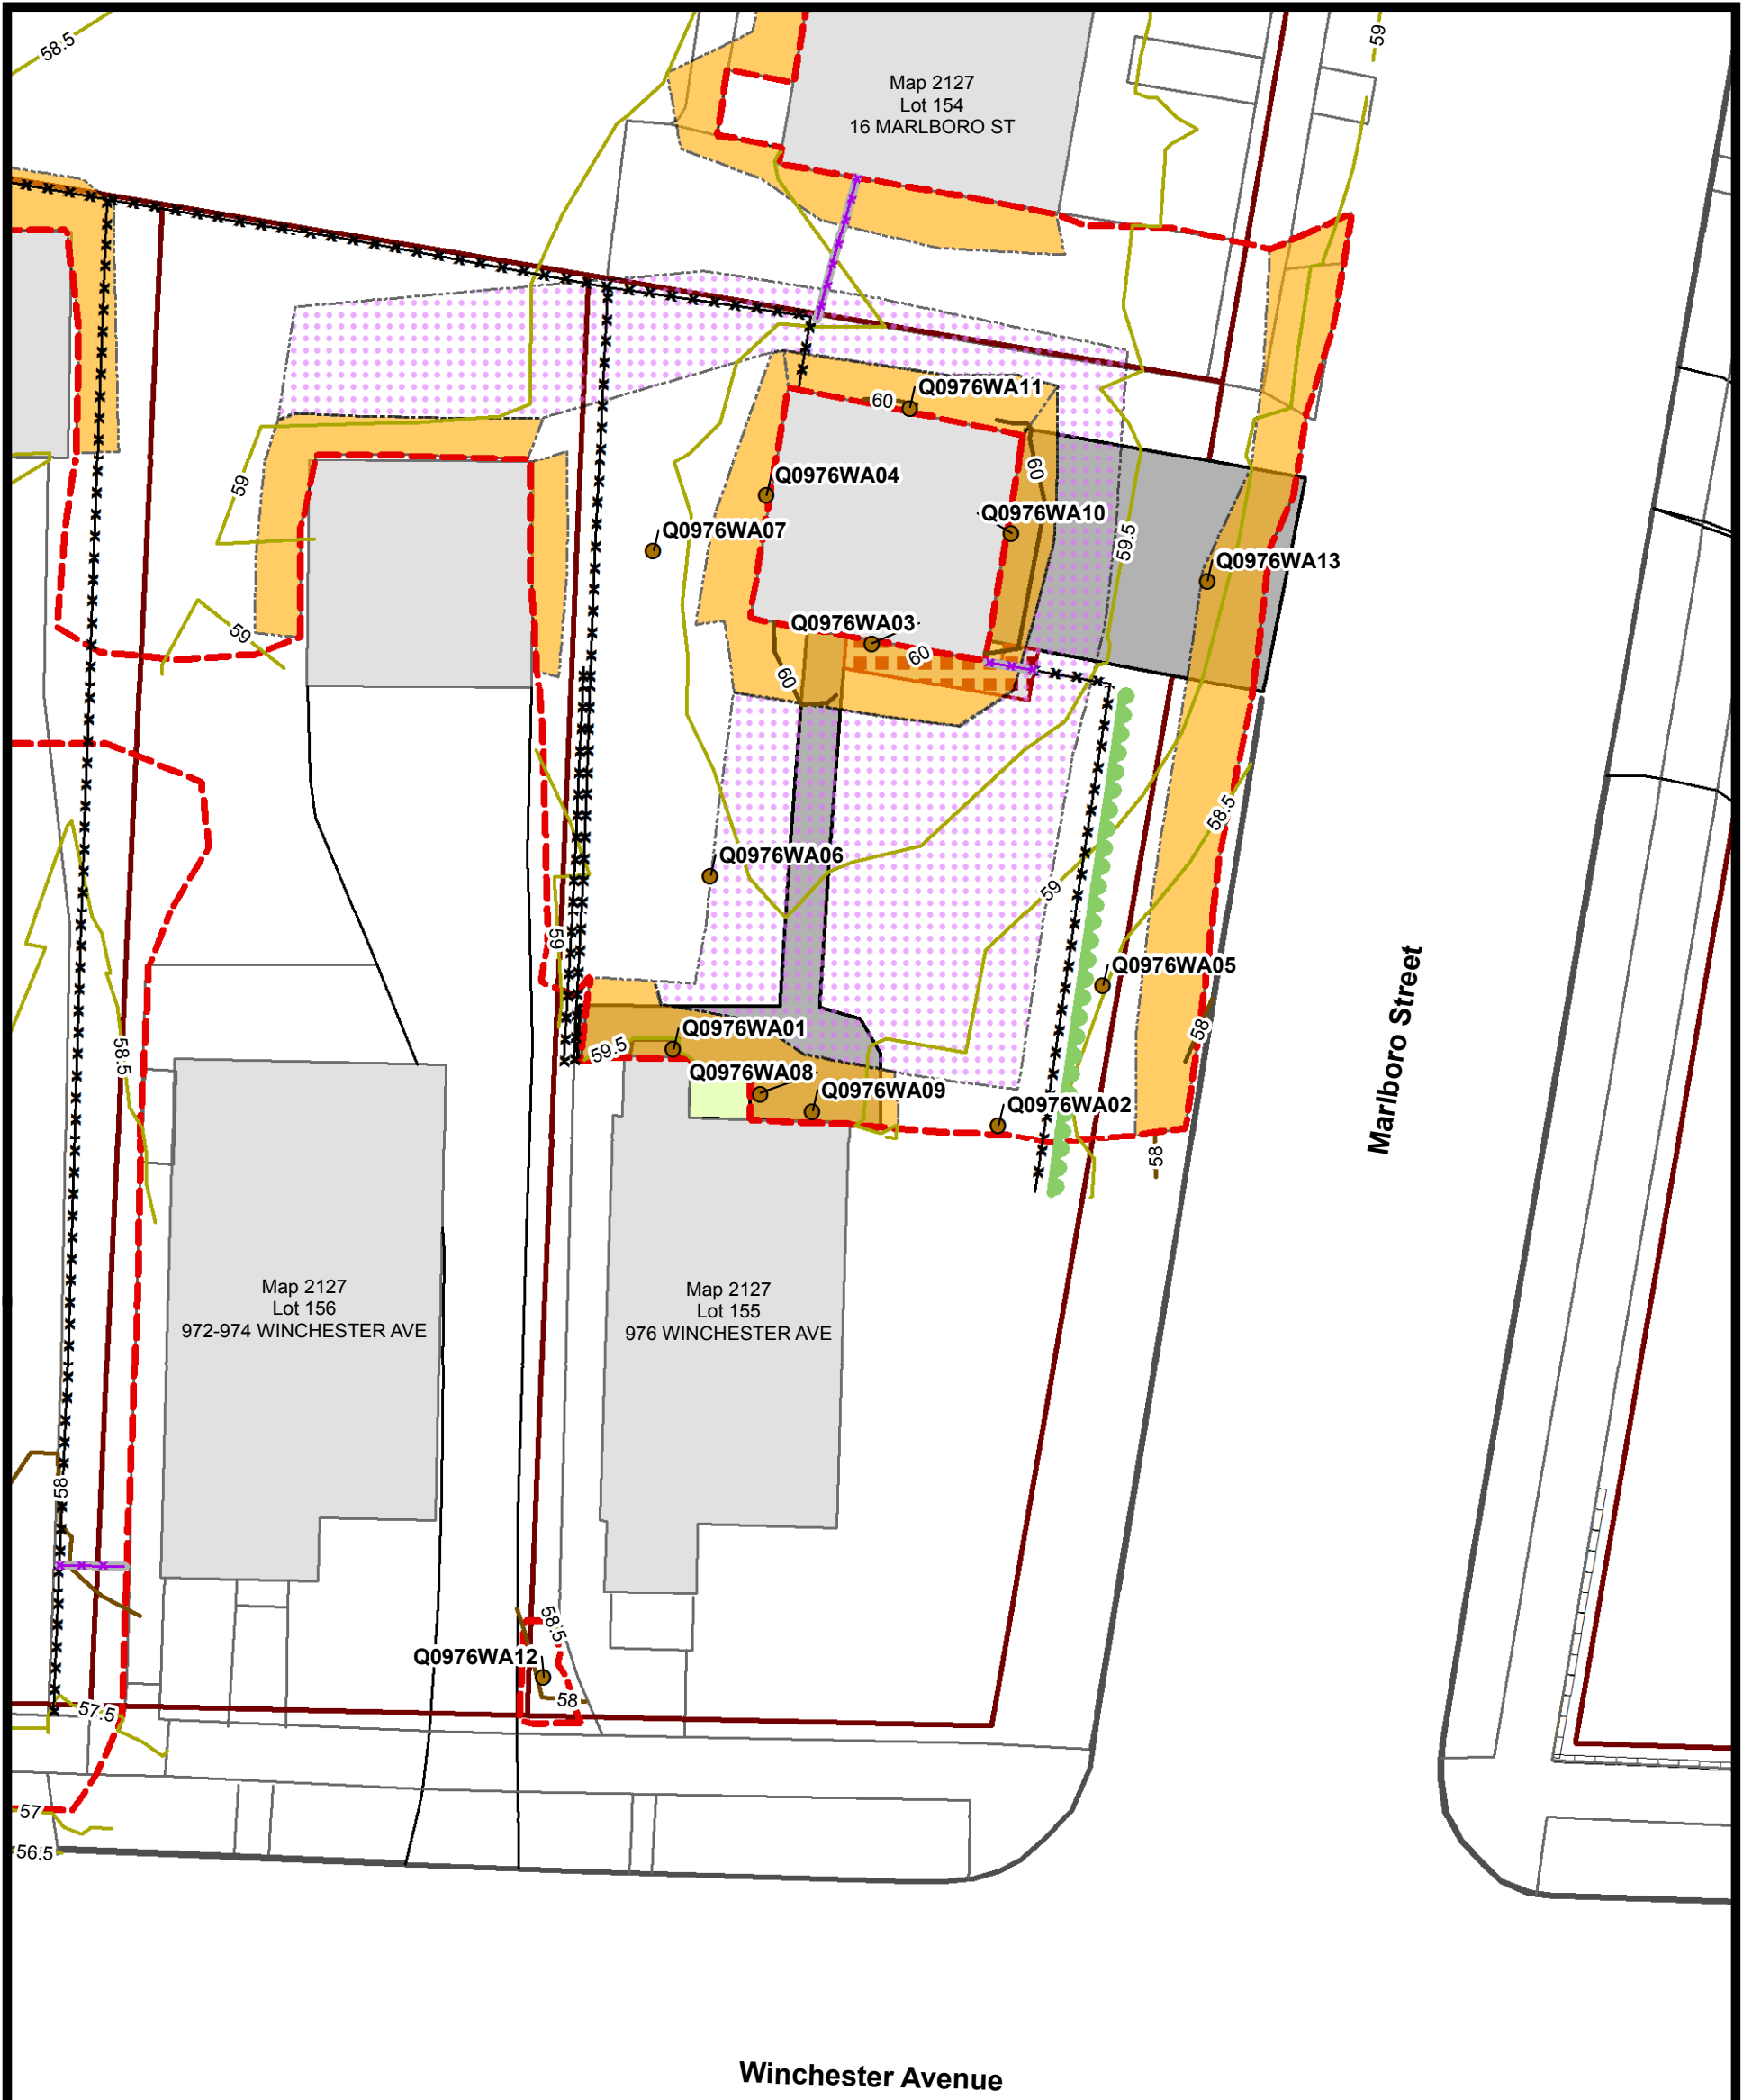
During the 2012 construction season, Olin completed the excavation, backfill, and restoration of the property in accordance with the Final Design - Generic RAP and the Property-Specific RAP. Figure 2-1 shows the areas where excavation occurred on the property and the locations of excavation confirmation samples. Excavation confirmation samples were collected in accordance with Section 3.2.3 - Confirmatory Sampling of the Final Design - Generic RAP, including adherence to the sampling frequency requirements. X-ray fluorescence (XRF) excavation confirmation sampling results are presented in Table 2-1.

- In some locations on the property, fill material was present at depths greater than 4 feet below ground surface (bgs). This fill material was left in place, covered by an orange geotextile fabric, and backfilled with clean soil in accordance with the Final Design - Generic RAP. Figure 2-1 shows the approximate area of geotextile fabric identifying the presence of fill at a depth greater than 4 feet bgs.

- In some locations, it was necessary to leave fill material in place at depths less than 4 feet bgs in order to avoid jeopardizing the integrity of a structure or feature that was to be left in place. This fill material was left in place, covered by an orange geotextile fabric and/or concrete, and backfilled with clean soil in accordance with the Final Design - Generic RAP. Figure 2-1 shows the approximate area of geotextile fabric/concrete identifying the presence of fill at a depth less than 4 feet bgs.

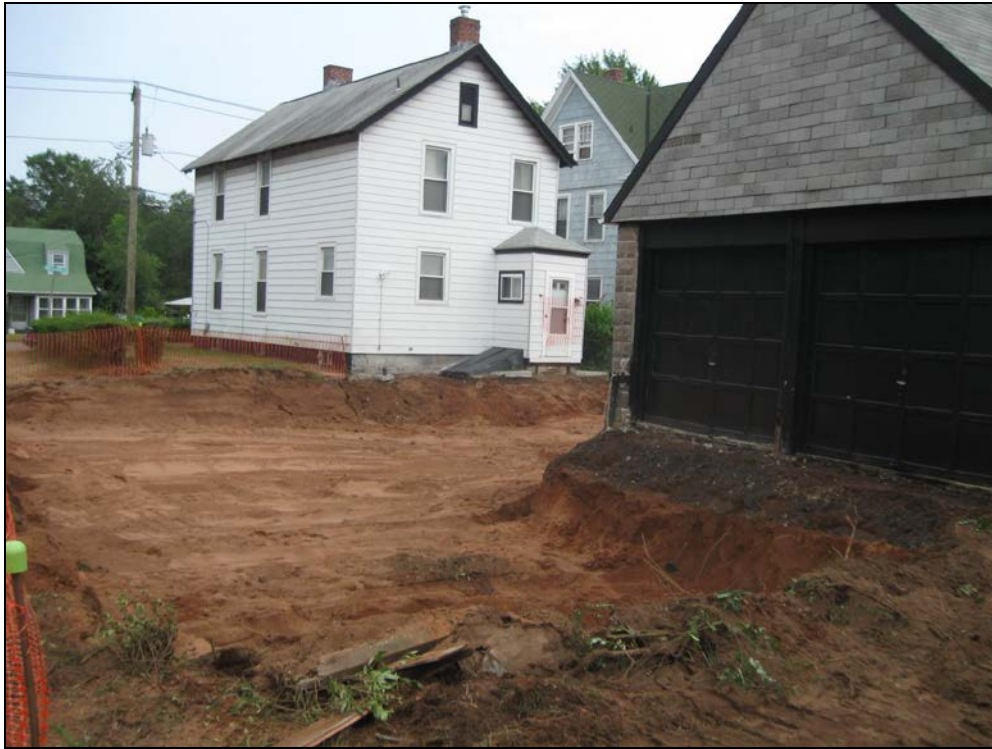
View looking east at excavated driveway and backyard.

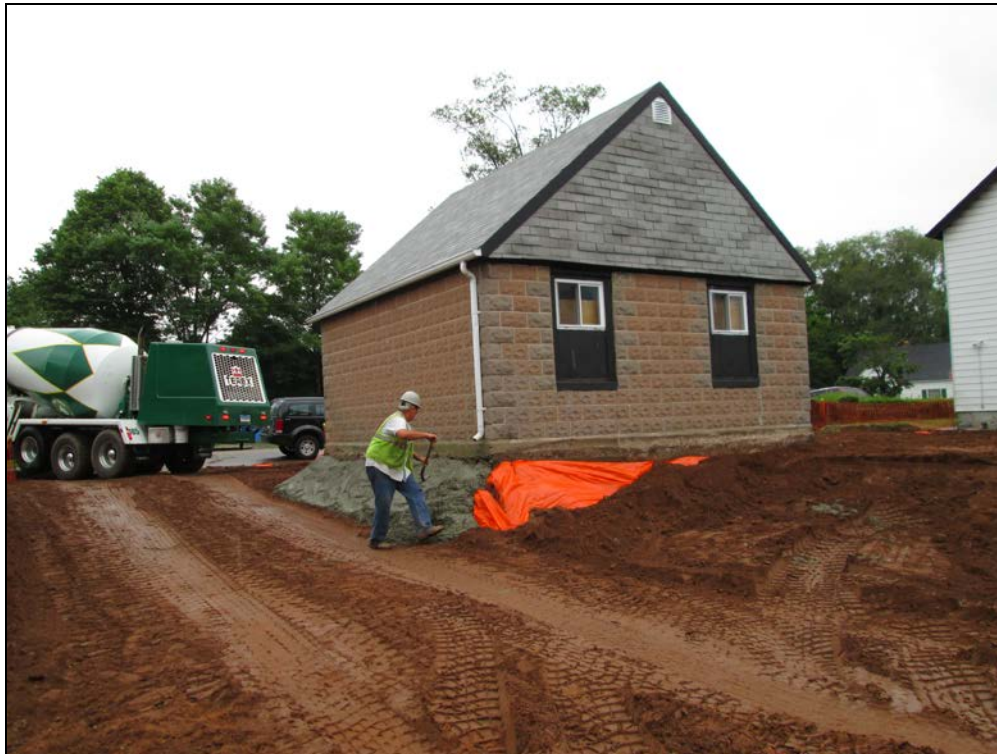
View looking northeast at partially backfilled garage area.

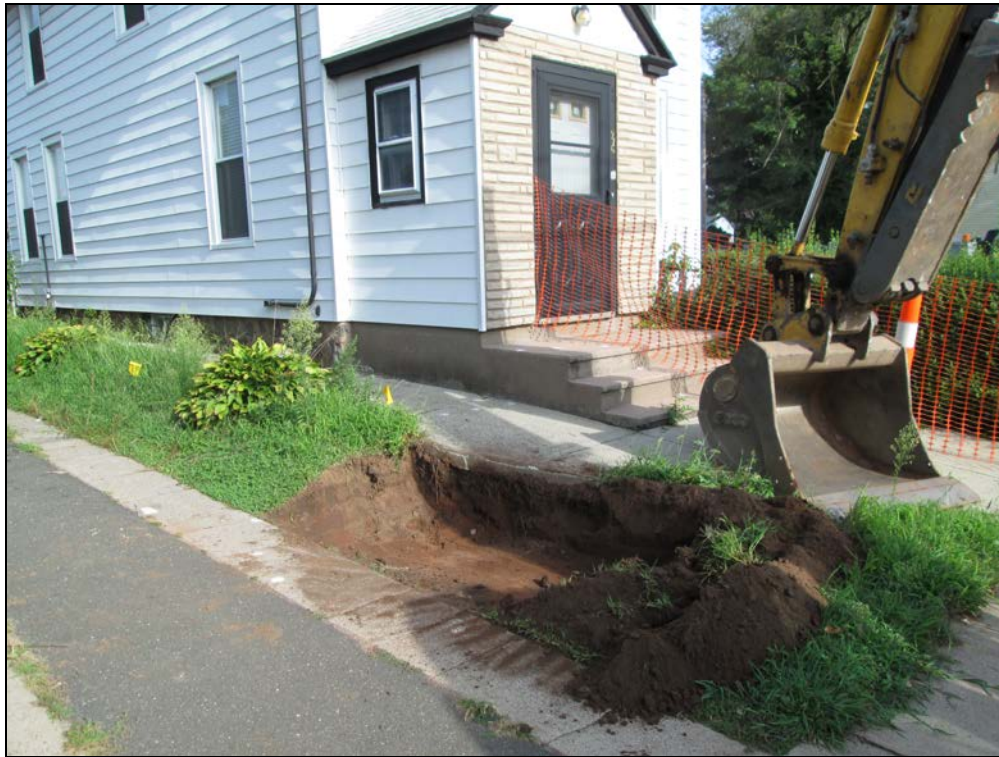
View looking northwest at excavation of isolated fill area in front yard.

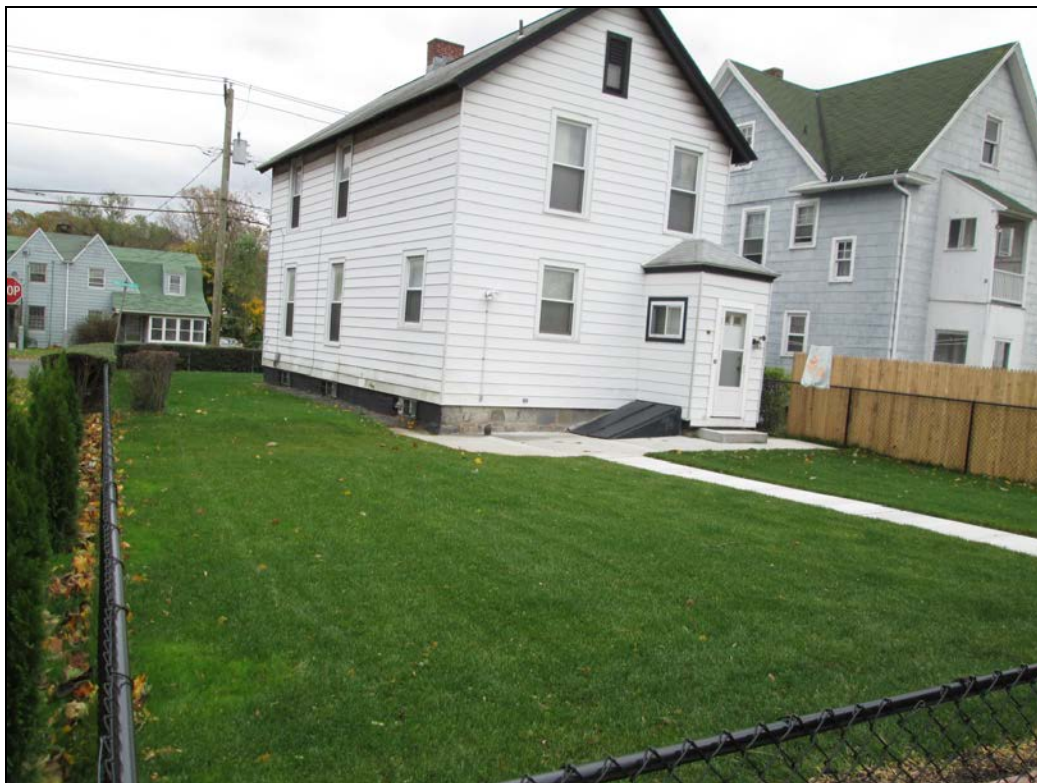
View looking east at restored back yard.

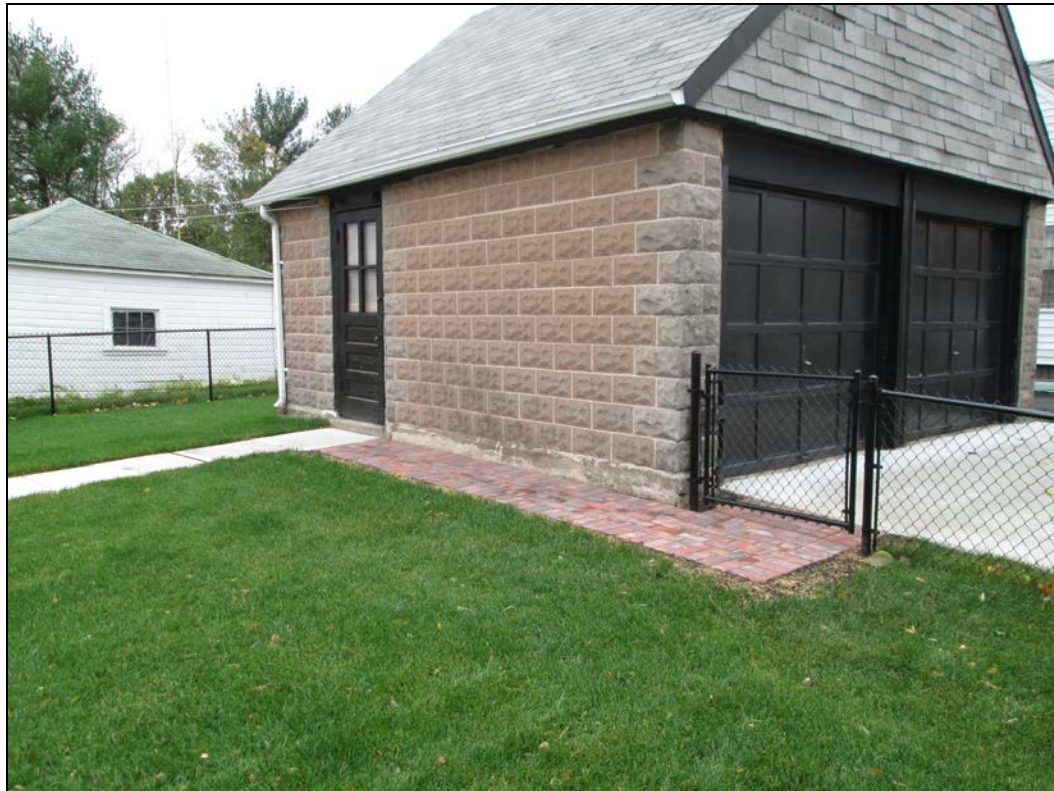
View looking southwest at restored garage area.
